Quest Engineering & Failure Analysis, Inc.
www.quest-engineering.com

Re: Rebuttal Report

File: Bryson Accident
Quest No: 10519

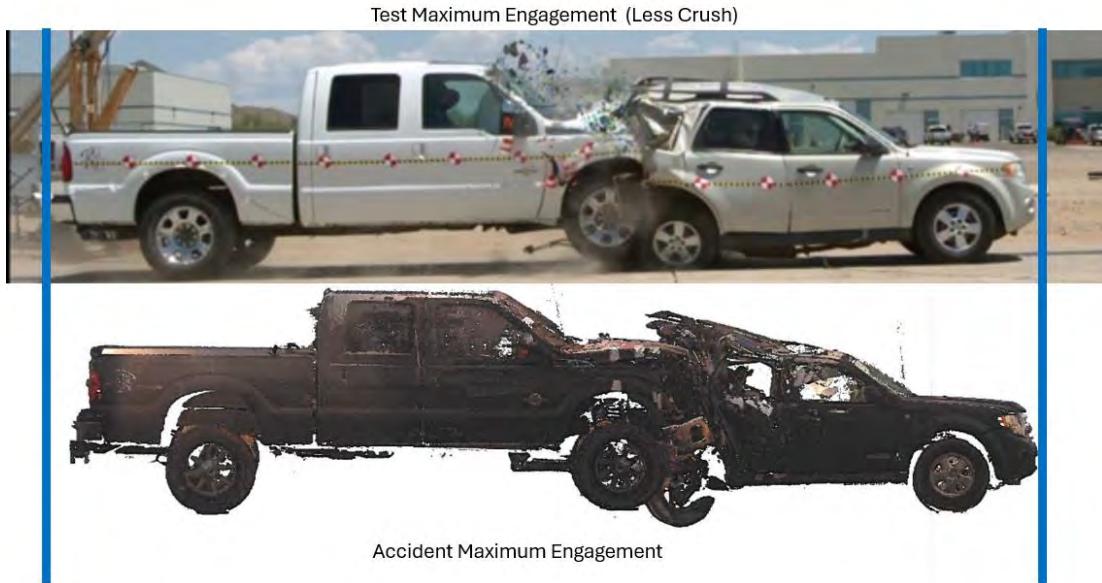
Figure 2: Comparison of Maximum Engagement

The point of maximum engagement between the **test** vehicles is in the crash test video. When comparing the crash test to the 3D model of the **accident** vehicles at maximum engagement, there was less penetration into the rear passenger compartment than on the accident Escape (*Figure 2*).

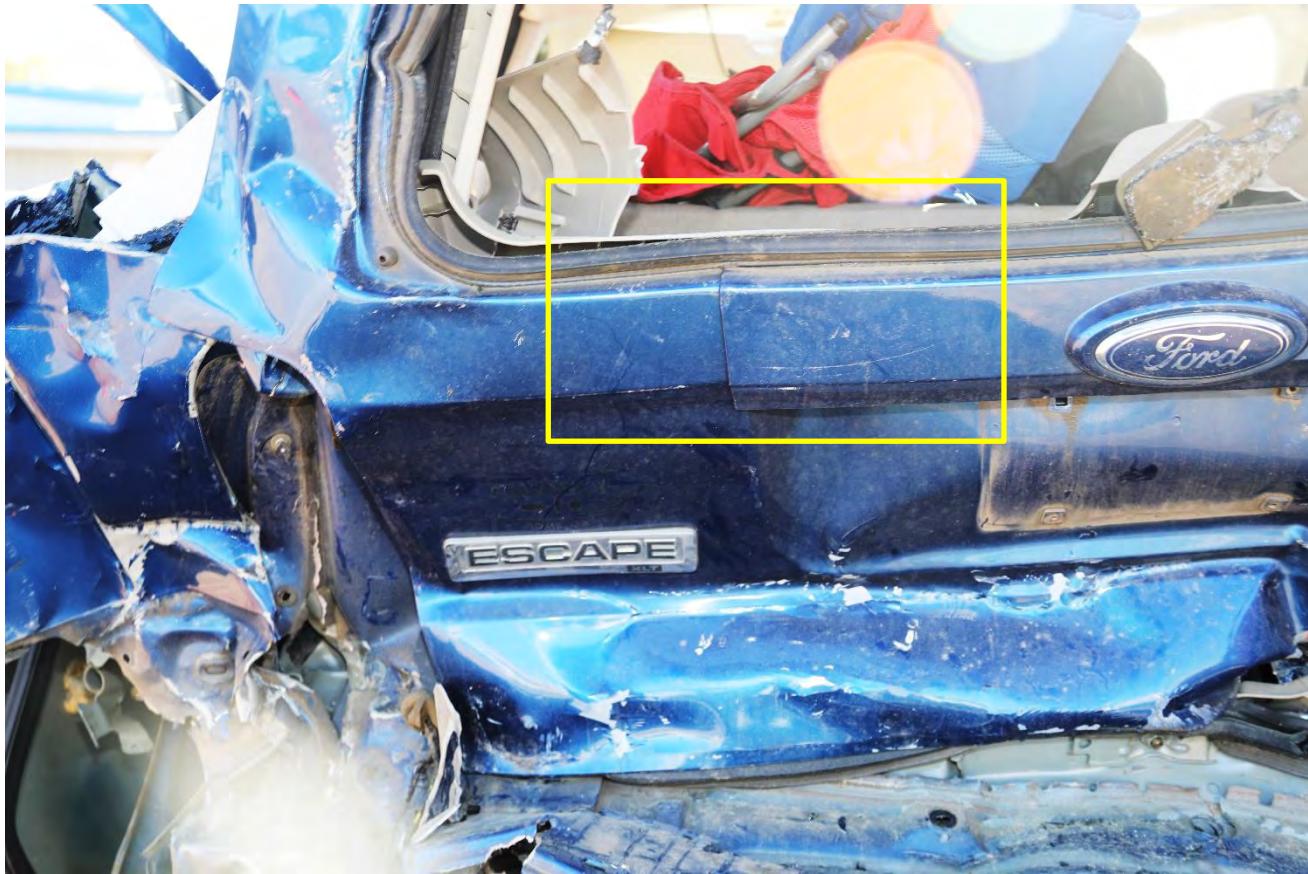
Figure 3A: Crash test photo 12327PH_0385

photos taken by Jeff Kidd on April 3, 2020 and the test Escape's imprint was visible in Exponent's crash test photos. The photos were sufficient to create a photomodel of the rear of both vehicles. The photomodels were then scaled using measurements from the scans of the respective vehicles. The imprints were then measured from the centerline of the Escape, which resulted in a difference of 4.7 inches laterally (*Figure 4*).

Figure 3B: Jeff Kidd 4/3/2020 inspection photo 106

Figure 4: Accident Escape and test Escape photomodels with measurements from centerline to left edge of Ford logo imprint

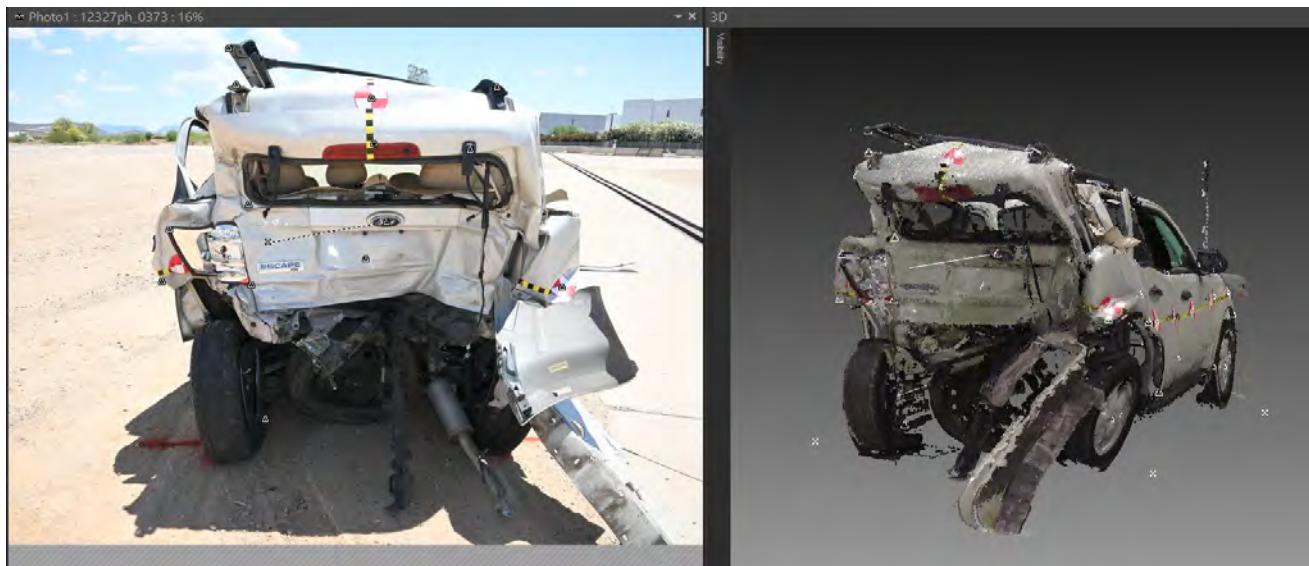
Figure 5A: Photogrammetry analysis of the accident Escape

the camera parameters were solved, the photo was measured, which resulted in a difference of 4.9 inches laterally (*Figure 5*).

Figure 5B: PhotoModeler Premium analysis of the test Escape

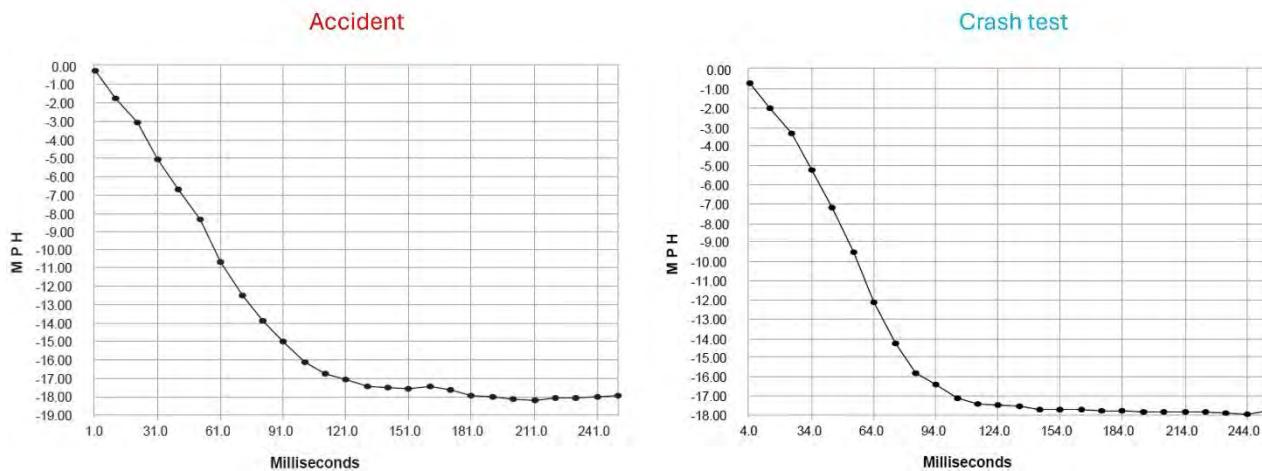
Figure 7: Longitudinal crash pulse comparison

As identified above, the crash pulses of the **test** F250 and the **test** Escape can be compared with respect to generally accepted principles of classical physics and accident reconstruction. The two F250 crash pulses are shown below (*Figure 7*). In engineering, the rate of change of velocity is the acceleration and by Newton's Law of Motion is directly related to the applied force. Thus, the steeper the crash pulse, the greater the applied force. Since the **test** "change of velocity pulse" verses "time pulse" is steeper, it represents greater deceleration of the **test** F250 per unit time and thus greater applied force on the front of the truck to slow it down faster. The source of this force is, of course, the presence of the **test** Escape. Because there is a greater force in the **test**, the **test** Escape was stronger in the region impacted than in the accident even though there was less of the Escape available directly in front of the **test** F250 to resist the truck (because of the offset problem shown above). The steeper crash pulse does demonstrate that when impacted at the lower elevation, the Escape provides more resistance and therefore is stronger and because energy is the product of force and distance, the crush distance mathematically must be lower. Thus, just from the accelerometer data recorded in the **accident** and **test** F250's, and using physics, the lift kit resulted in an increased amount of **accident** Escape crush when compared to an impact with a non-lifted F250. The calculations are as follows:

- **Accident** F250 Crash Pulse slope from 31 ms and 5.10 mph to 91 ms and 14.96 mph is -7.5 g's
- **Test** F250 Crash Pulse slope from 34 ms and 5.24 mph to 94 ms and 16.42 mph is -8.5 g's
- **Test** Deceleration Minus **Accident** Deceleration equals one G (the weight an F250 or about 8500 to 9000 pounds)

Thus, when the lift kit was removed from the F250, the **test** Escape was able to generate about 8,500 to 9,000 pounds more force to resist crush than when struck by a lifted truck because the bumper level structures of the Escape were better engaged as it was a bumper-to-bumper level impact. The actual increase in resistive force would have been higher had the offsets been proper because there would have been more lateral overlap by 5 inches and thus even more of the Escape structure would have been directly engaged.
